# About the firmware version 2.36 update

Last Modified: June 29th, 2016

This release of the hPDU firmware is a stability update following version 2.34 where **ring redundancy** and **configurable permissions for the user role** were added. It also fixes some other issues and is advised for all users of the hybrid range of PDUs and DPM3.

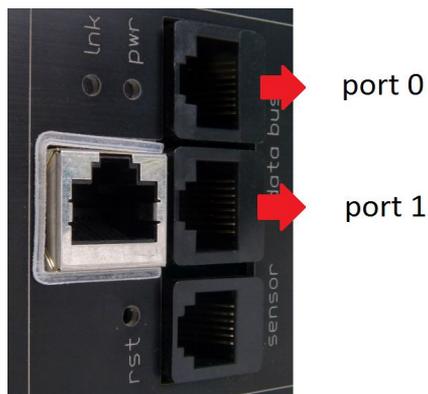
2. In all firmware versions until version 2.34 both data bus ports of an hPDU were always behaving the same in all device modes. From version 2.34 and up there is a difference between the two data bus ports when using Bridge or Twin mode!

When performing a data bus scan using the API, devices on data bus port 1 (see image) are buffered before they are sent to the client. This causes some delay between devices found on data bus port 0 and port 1. The user should take care of this delay.
